RE: Update on Structural Shoring for Damaged Roof Section  
Ref. Drawings:  
JM Albain Engineering, Dwgs S-1 to S-6 dated 10/25/10  
Dwgs. S-6, S-7 rev. 1, (DCN #1) dated 01/26/11  
Project # JMA10-327-06

RE: Structural Shoring for Damaged Roof Section  
Ref. Drawings:  
JM Albaine Engineering, Dwgs S-1 to S-6 dated 10/25/10  
As-built Dwgs. S-1 to S-8, dated March 5, 2011 Rev. 2  
Project # JMA10-327-06

Temporary Framing Inspection  
REPORT #1 --- October 31, 2022

Subject: Oswegatchie Fire Station  
Inspection /Assessment: Building Structural Safety  
Project # JMA22-327-062

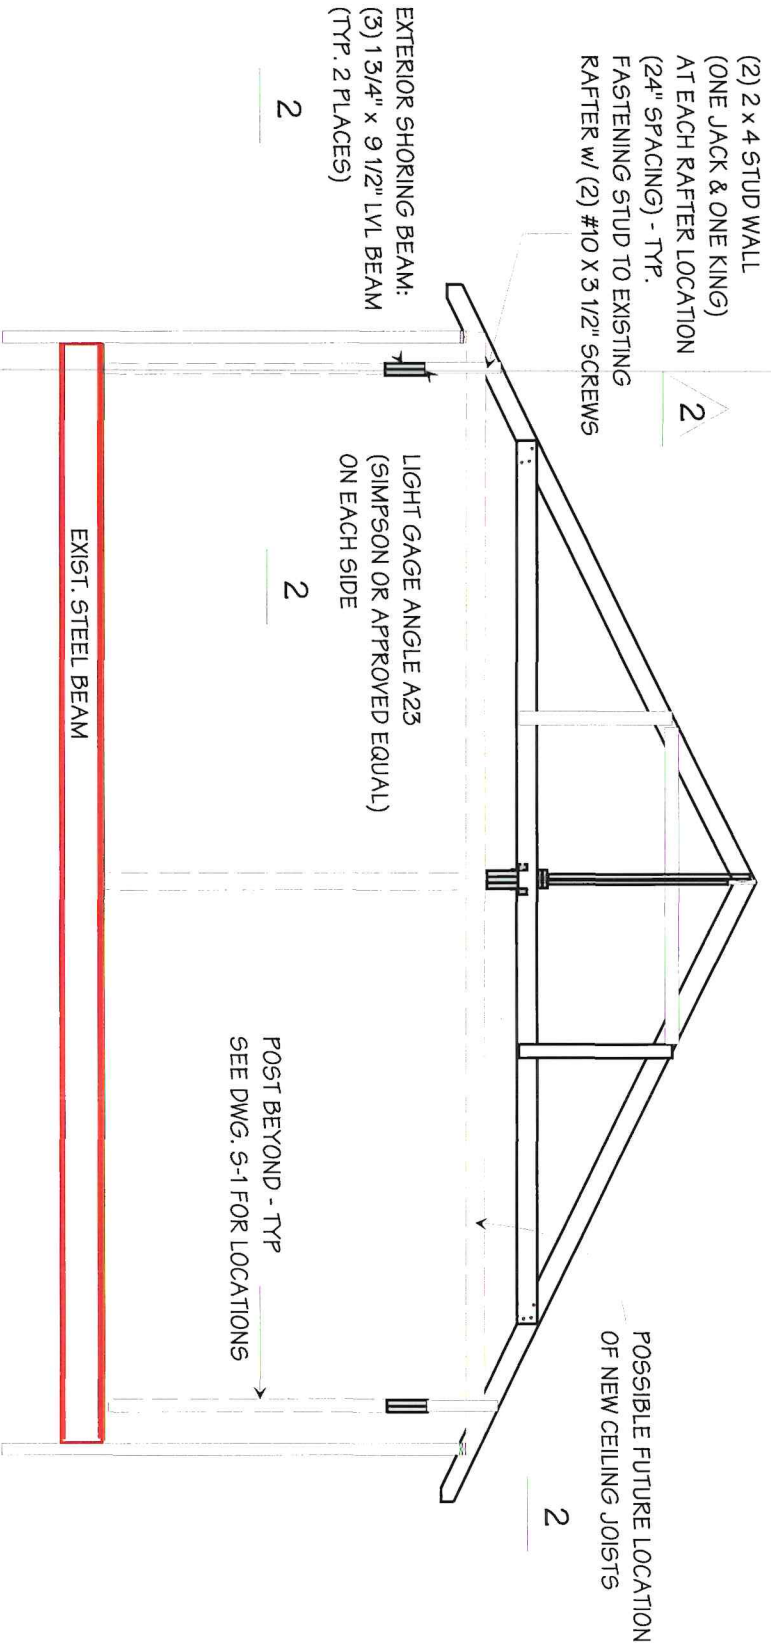
DC2-1

TEMPORARY SUPPORT BEAM: (3) 1 3/4 x 9 1/2" LVL

CANTILEVER  
MAX. 2'-6"

INTERSECTION PLANE BETWEEN  
THE TWO MAIN ROOFS  
FRAMING FOUND IN A VERY  
WEAKENED STATE - SURVEY COMPLETELY  
AFTER THE INSTALLATION OF THE SHORING

THE FINAL LOCATION OF THESE 3 COLUMNS  
TO BE DETERMINED AFTER CEILING IS REMOVED

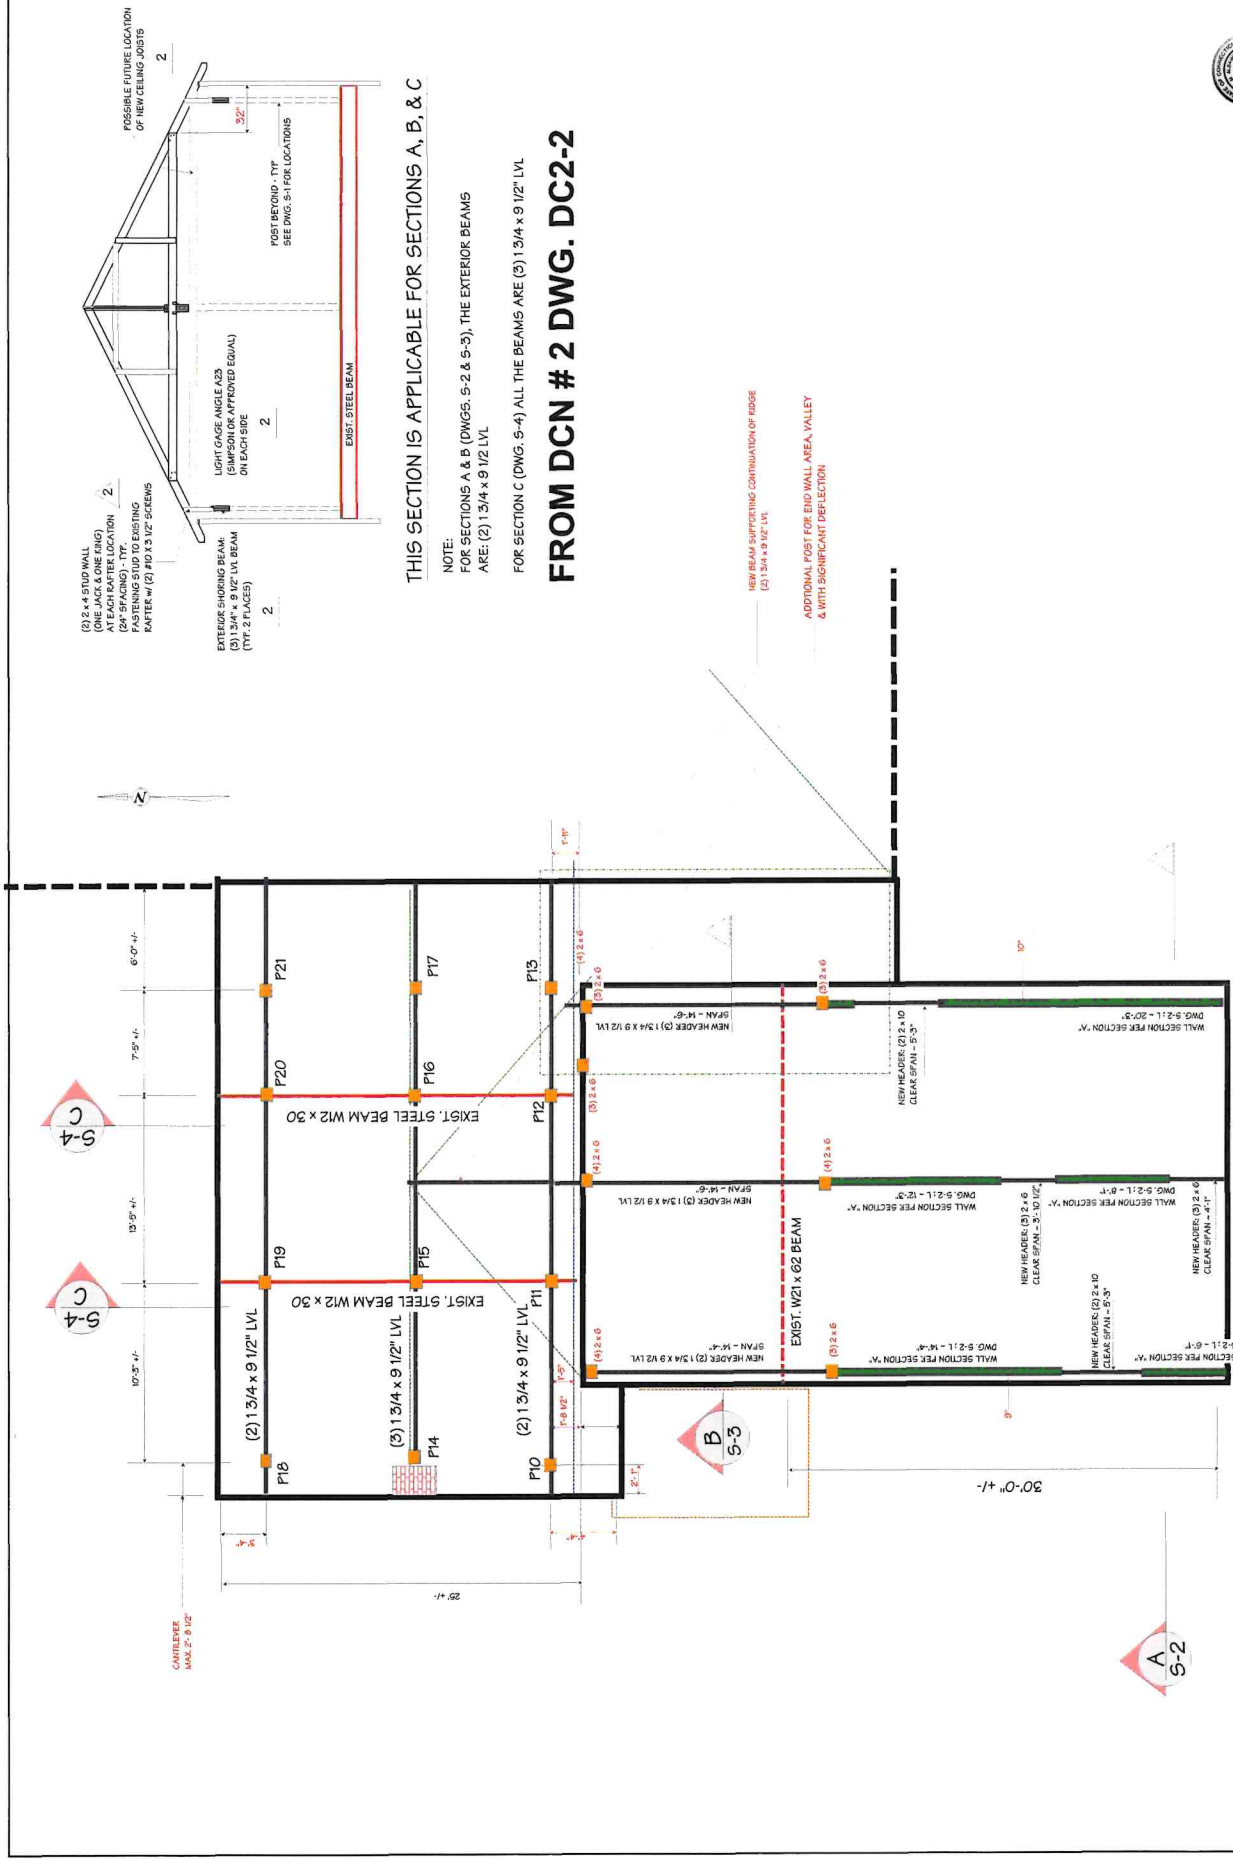
### AS-BUILT SHORING STRUCTURE AT THE UPPER LEVEL

THIS SECTION IS APPLICABLE FOR SECTIONS A, B, & C

NOTE:  
FOR SECTIONS A & B (DWGS. S-2 & S-3), THE EXTERIOR BEAMS  
ARE: (2) 1 3/4 x 9 1/2 LVL

FOR SECTION C (DWG. S-4) ALL THE BEAMS ARE (3) 13/4 x 9 1/2" LVL
