RE: Update on Structural Shoring for Damaged Roof Section  
Ref. Drawings:  
JM Albain Engineering, Dwgs S-1 to S-6 dated 10/25/10  
Dwgs. S-6, S-7 rev. 1, (DCN #1) dated 01/26/11  
Project # JMA10-327-06

RE: Structural Shoring for Damaged Roof Section  
Ref. Drawings:  
JM Albaine Engineering, Dwgs S-1 to S-6 dated 10/25/10  
As-built Dwgs. S-1 to S-8, dated March 5, 2011 Rev. 2  
Project # JMA10-327-06

Temporary Framing Inspection  
REPORT #1 --- October 31, 2022

Subject: Oswegatchie Fire Station  
Inspection /Assessment: Building Structural Safety  
Project # JMA22-327-062

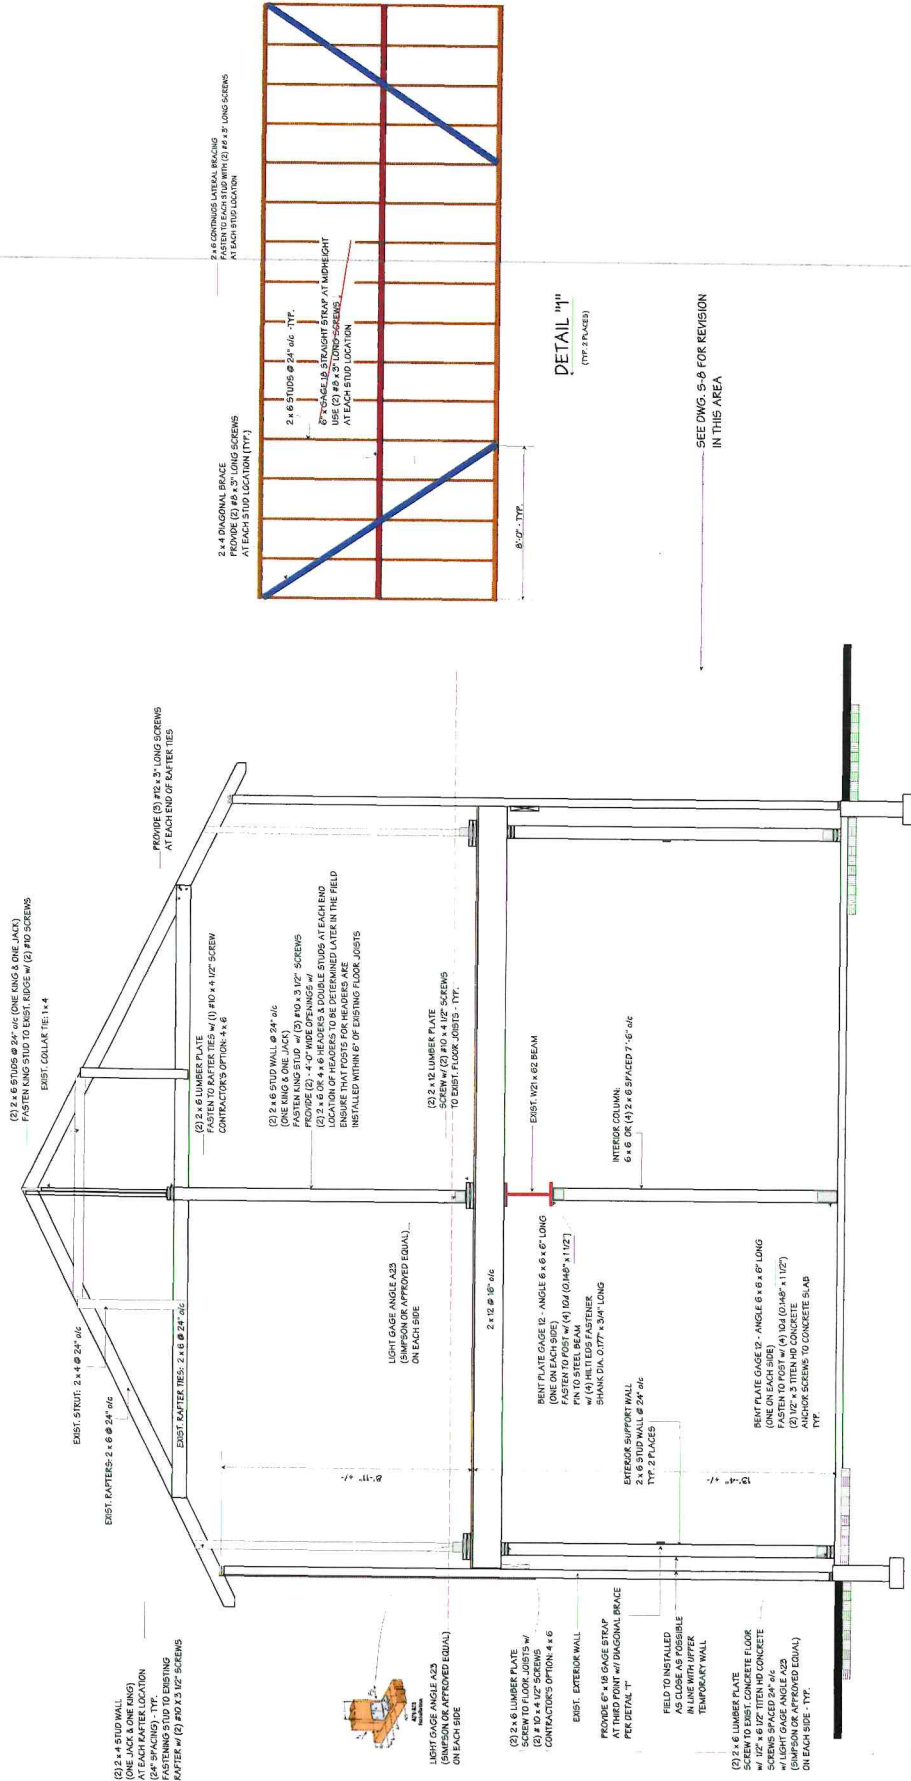
## SECTION / A

3. The temporary beams supporting the exterior edges of the roof, at both above the Hall Room and Kitchen (second floor, see Sections A, B, & C (Dwgs S-2, S-3 and S-4) will be installed at a lower elevation, with a short double stud (one king and one jack) above it, to make room for the potential installation of the future new ceiling joist.

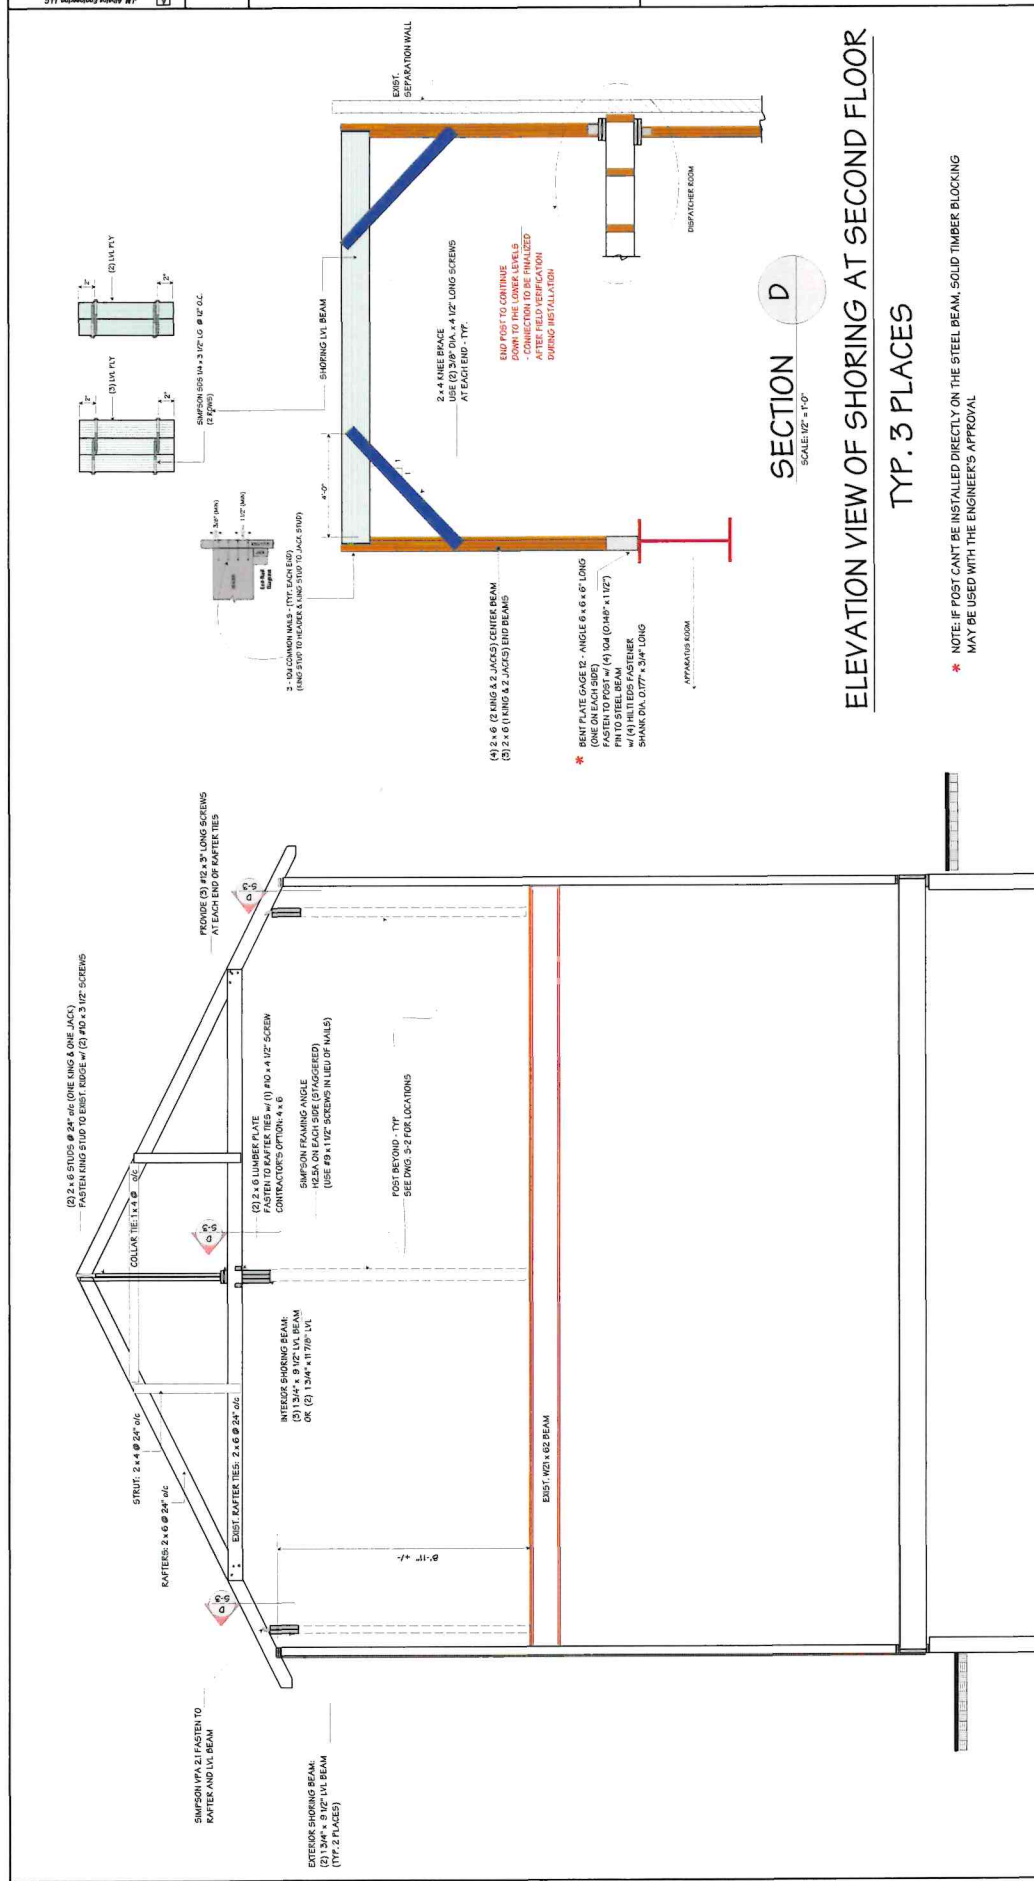
SECTION D  
SCALE: 1/2" = 1'-0"

ELEVATION VIEW OF SHORING AT SECOND FLOOR  
TYP. 3 PLACES

\* NOTE: IF POST CAN'T BE INSTALLED DIRECTLY ON THE STEEL BEAM, SOLID TIMBER BLOCKING MAY BE USED WITH THE ENGINEER'S APPROVAL

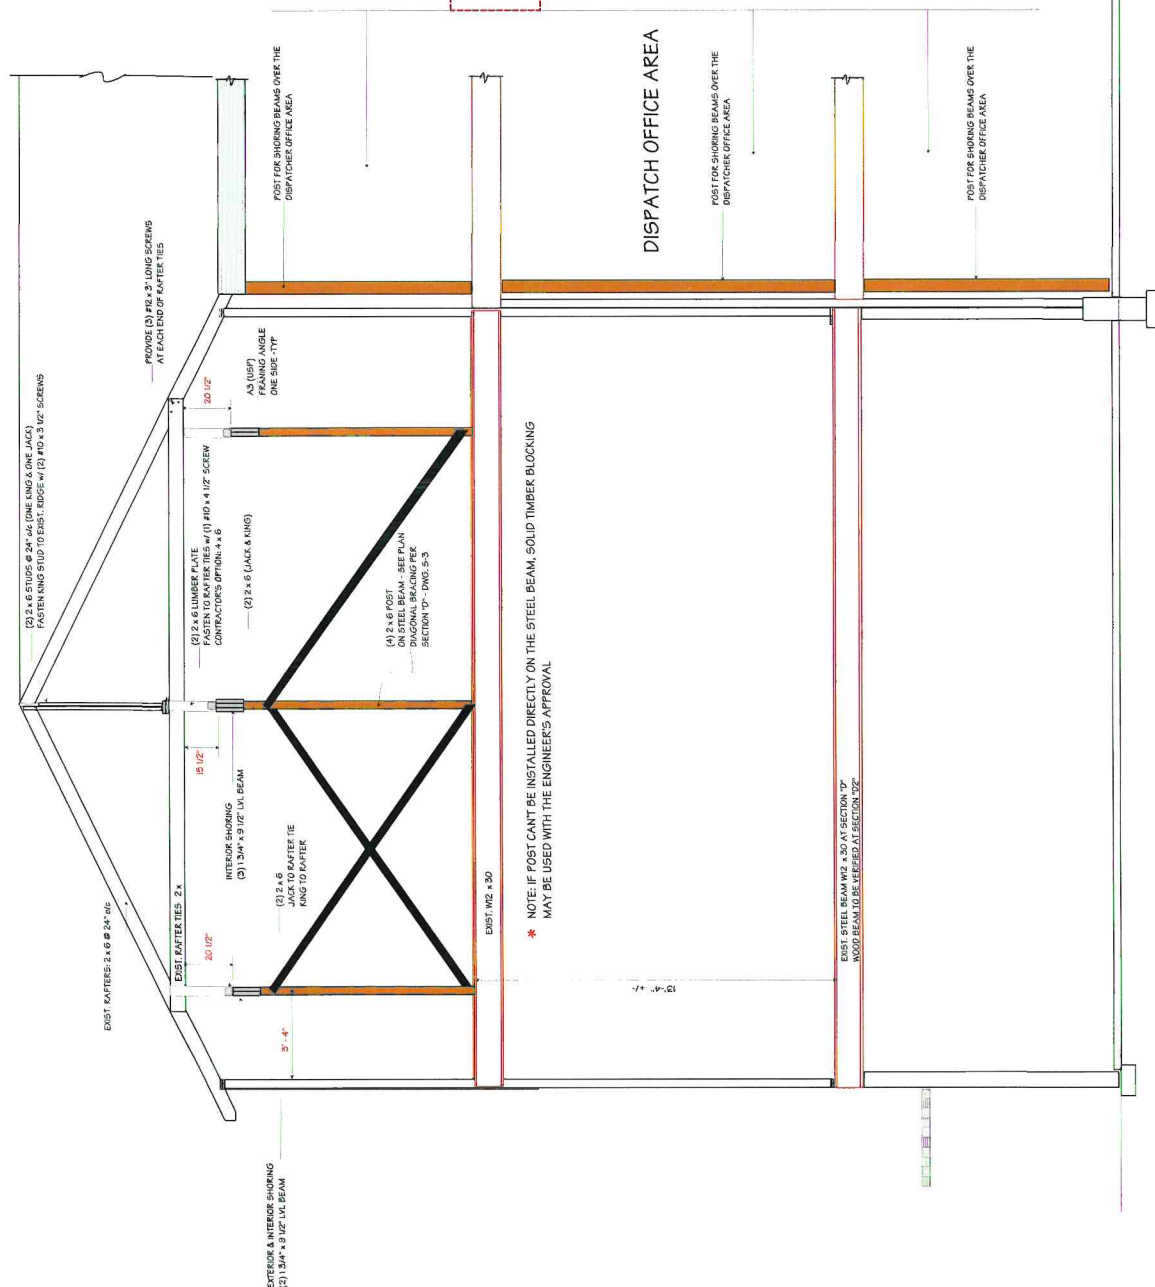
NOTE:  
CONTRACTOR TO COORDINATE w/ ENGINEER THE LOCATION  
OF THESE POSTS ONCE THE AREA IS OPENED FOR SHORINGS

\* NOTE: IF POST CAN'T BE INSTALLED DIRECTLY ON THE STEEL BEAM, SOLID TIMBER BLOCKING MAY BE USED WITH THE ENGINEER'S APPROVAL

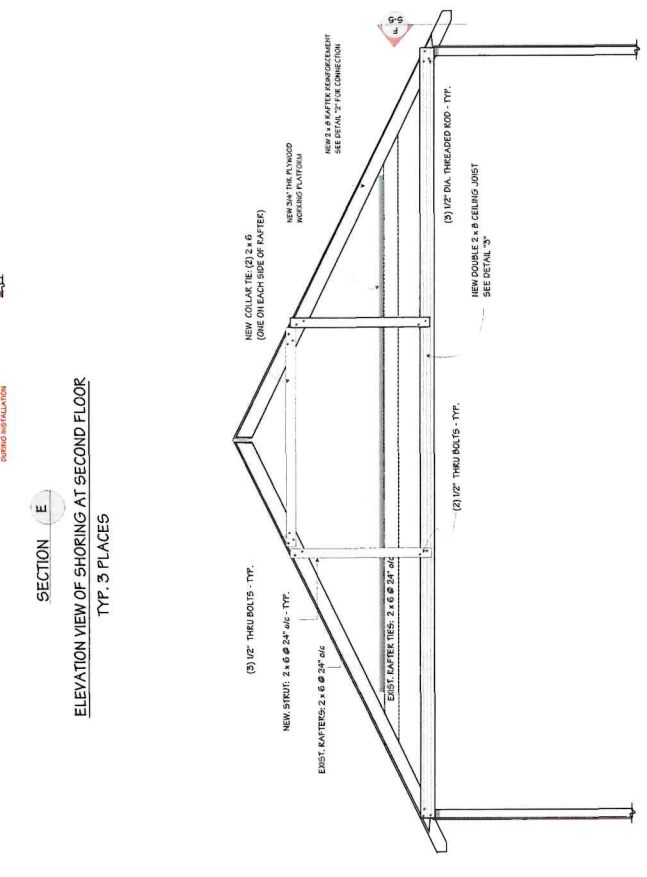
CONCEPTUAL DESIGN FOR ROOF REINFORCEMENT  
(FOR PRELIMINARY CONSTRUCTION ESTIMATE COST)

Note that this is a conceptual design and that more analysis is required to develop the final design reinforcement to fit the existing condition.
